Grand Parkway Houston, TX

Case Study

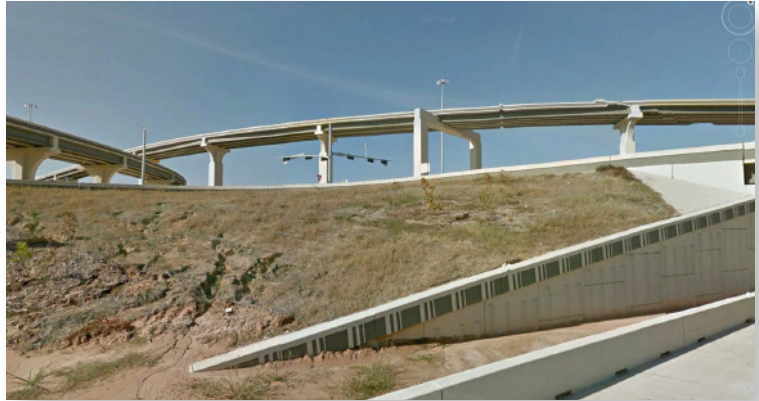
Significant rilling and lack of vegetation was common in the project area. March, 2018.

have repeated in successive segments. A significant cause of these issues was the fact that soil conditions were extremely sandy with significant nutrient deficiencies and low organic matter content. Additionally, the soil was prone to crusting, making successful vegetation extremely difficult to achieve.

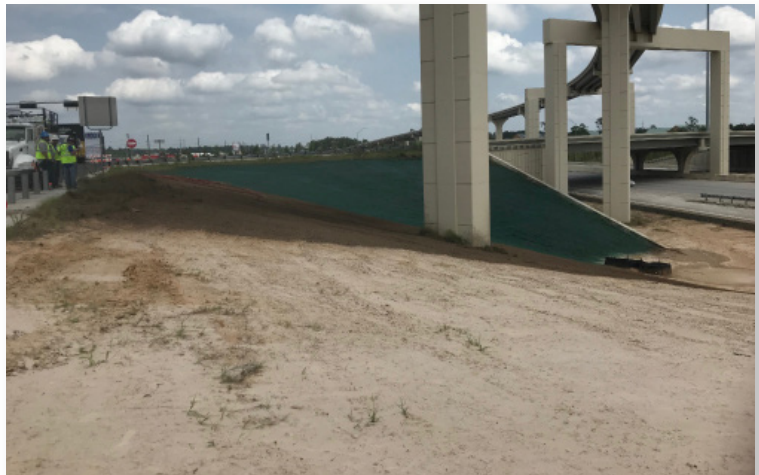
Applegate Woodlok HP covered the Biotic Earth for erosion control. March 2018.

Eddie George with Webber Construction consulted a group consisting of manufacturers, distributors, and contractors to come up with a successful solution to this problem. Biotic Earth, a Biotic Soil Amendment by ECBVerdyol was chosen for its effectiveness at soil improvement, germination improvement, and success at vegetation establishment. With the successful vegetation establishment that could be achieved through the use of Biotic Earth, hydraulic erosion control was sufficient for most areas. Seed mix was the TXDOT required blend for the location.

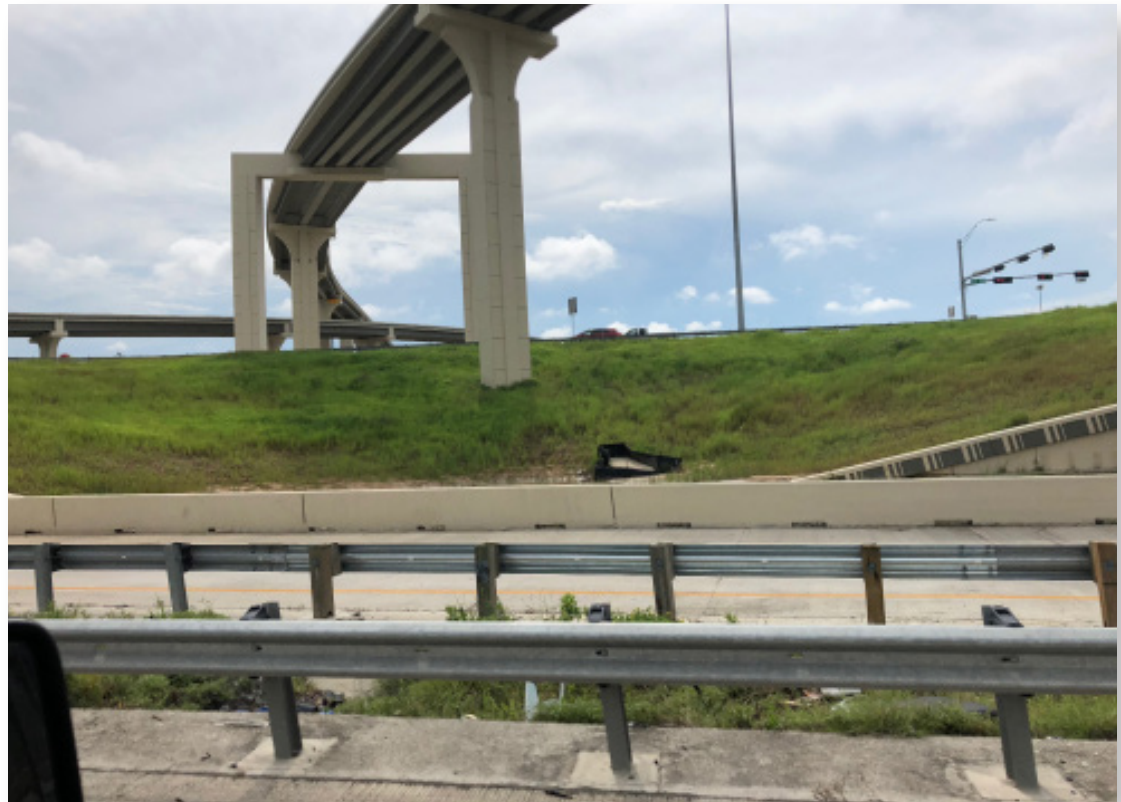
Example: Successful vegetation achieved in 3 months. July, 2018.

The site received a significant rain event within two weeks of being installed with no erosion or rilling. Germination was fast and excellent cover of vegetation was achieved in spite of one of the hottest summers on record in conditions that historically had significant issues achieving successful vegetation results. By July of 2018 a thick stand of multi species vegetation had been achieved.
